Report No. A223054740410103

Sample Name	Ipex MHF I to 1.13 cable to RP SMA S/T Bulkhead Jack w/o-ring	Ipex MHF I to 1.13 cable to SMAS/T Bulkhead Jack w/o-ring
Part No.	CAB603RF-XXXX-XX-X-1	CAB602RF-XXXX-XX-X-1
Sample Receiving State	Normal	Normal
Sample Received Date	Oct. 23, 2023	
Testing Period	Oct. 23, 2023-Oct. 30, 2023

Test Report

Test Item: IPX5**1. Test Equipment**

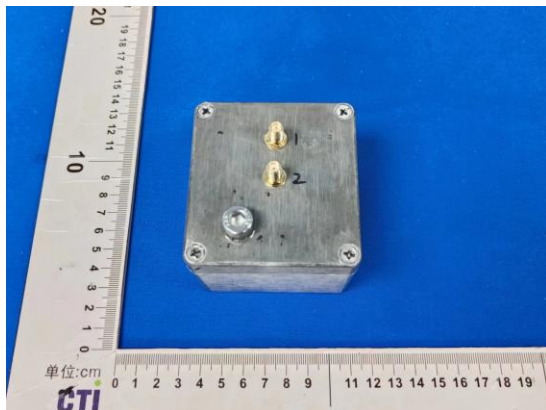
Sample No.	Sample Name	Type	Quantity
A2230547404101001	Ipex MHF I to 1.13 cable to RP SMA S/T Bulkhead Jack w/o-ring	CAB603RF-XXXX-XX-X-1	1pc
A2230547404101002	Ipex MHF I to 1.13 cable to SMAS/T Bulkhead Jack w/o-ring	CAB602RF-XXXX-XX-X-1	1pc

Sample Photo(s)

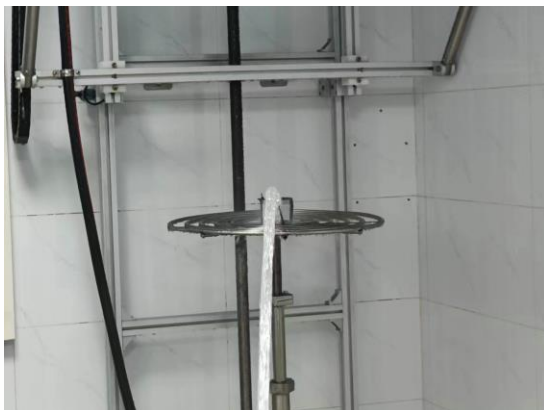
Sample No.	Criterion	Test result (Visual inspection)	Conclusion
A2230547404101001	There is no water inside the sample, if there is water can not enter or endanger live parts.	No water enters the sample	Pass
A2230547404101002	There is no water inside the sample, if there is water can not enter or endanger live parts.	No water enters the sample	Pass

Test Photo(s)

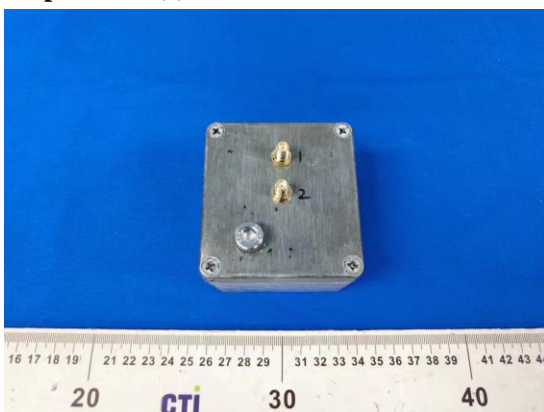
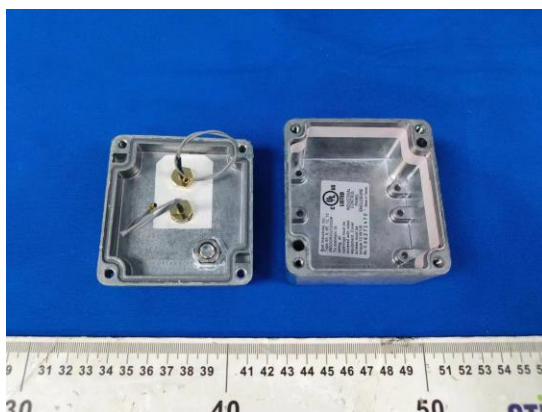
A2230547404101001

Sample Photo(s) after the test
