Report No. A223054740410102

Sample Name	Ipex MHF I to 1.13 cable to RP SMA S/T Bulkhead Jack w/o-ring	Ipex MHF I to 1.13 cable to SMAS/T Bulkhead Jack w/o-ring
Part No.	CAB603RF-XXXX-XX-X-1	CAB602RF-XXXX-XX-X-1
Sample Receiving State	Normal	Normal
Sample Received Date	Oct. 23, 2023	
Testing Period	Oct. 23, 2023-Oct. 30, 2023

Test Report

Test Item: IPX6**1. Test Equipment**

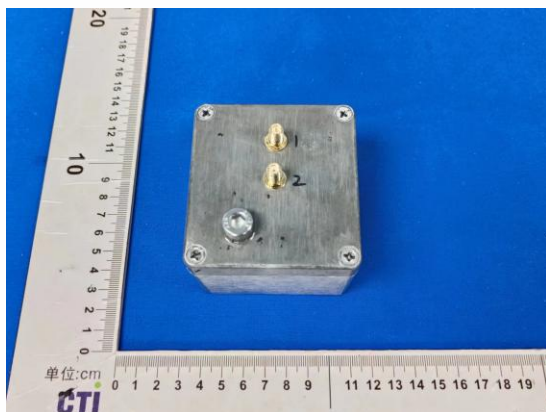
Sample No.	Sample Name	Type	Quantity
A2230547404101001	Ipex MHF I to 1.13 cable to RP SMA S/T Bulkhead Jack w/o-ring	CAB603RF-XXXX-XX-X-1	1pc
A2230547404101002	Ipex MHF I to 1.13 cable to SMAS/T Bulkhead Jack w/o-ring	CAB602RF-XXXX-XX-X-1	1pc

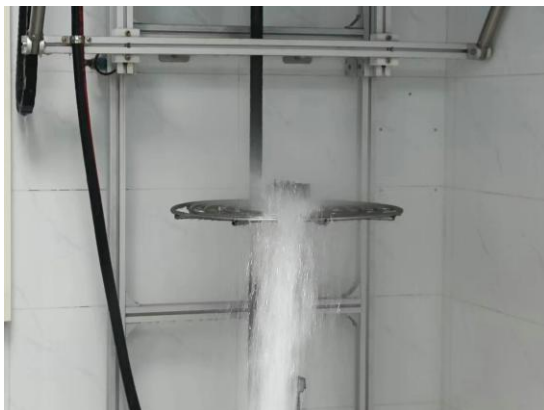
A2230547404101001

Test Photo(s)

Water flow:100L/min

Nozzle distance sample 2.5-3m

Nozzle inner diameter:12.5mm

Turntable speed:1r/min

Test time:3min

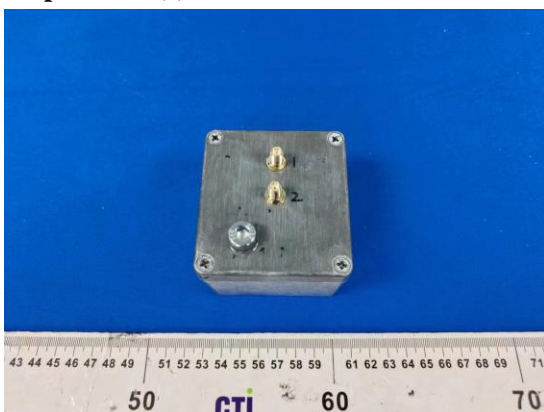
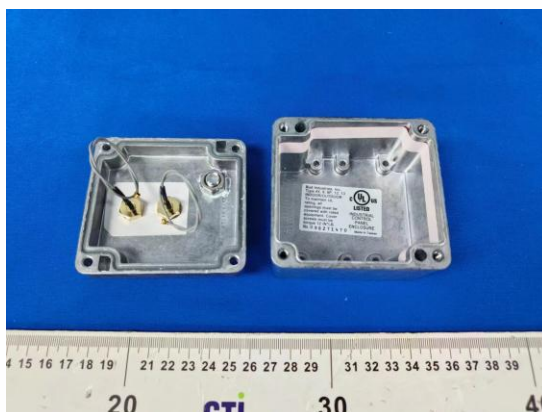
Sample No.	Criterion	Test result (Visual inspection)	Conclusion
A2230547404101001	There is no water inside the sample, if there is water can not enter or endanger live parts.	No water enters the sample	Pass
A2230547404101002	There is no water inside the sample, if there is water can not enter or endanger live parts.	No water enters the sample	Pass

Sample Photo(s) after the test
