Sample Name	Ipex MHF I to 1.13 cable to RP SMA S/T Bulkhead Jack w/o-ring	Ipex MHF I to 1.13 cable to SMAS/T Bulkhead Jack w/o-ring
Part No.	CAB603RF-XXXX-XX-X-1	CAB602RF-XXXX-XX-X-1
Sample Receiving State	Normal	Normal
Sample Received Date	Oct. 23, 2023	
Testing Period	Oct. 23, 2023-Oct. 30, 2023

Test Report

Test Item: IP6X**1. Test Equipment**

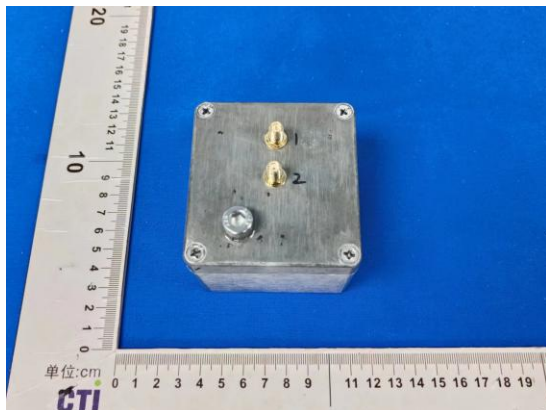
A2230547404101001

Sample Photo(s)

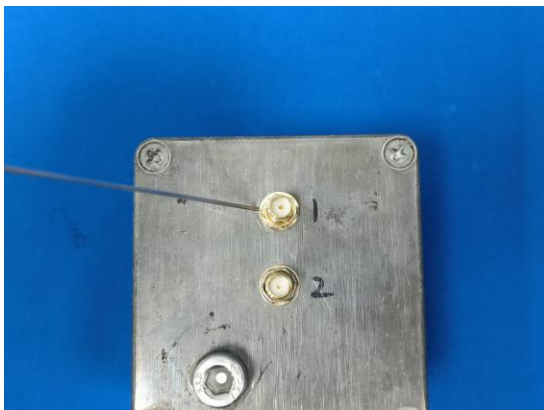
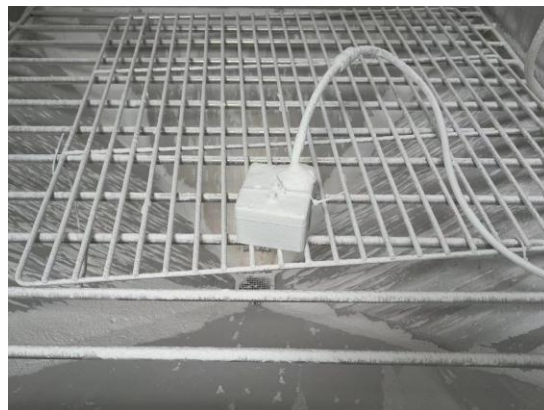
Use a test probe with a diameter of 1mm to probe the gap part of the sample with a force of 1N
Put the sample in a negative pressure state, the pumping rate is 40-60 times the volume of the shell per hour, and the pressure difference between the pressure in the shell and the atmospheric pressure is less than 2kPa, and the test is continuously performed for 2h in the dust-proof test box

Test Photo(s)

Sample No.	Criterion	Test result (Visual inspection)	Conclusion
A2230547404101001	The test probe cannot enter the inside of the sample, and the inside of the sample is dustless.	The test probe cannot enter the inside of the sample, and the inside of the sample is dustless.	Pass
A2230547404101002	The test probe cannot enter the inside of the sample, and the inside of the sample is dustless.	The test probe cannot enter the inside of the sample, and the inside of the sample is dustless.	Pass

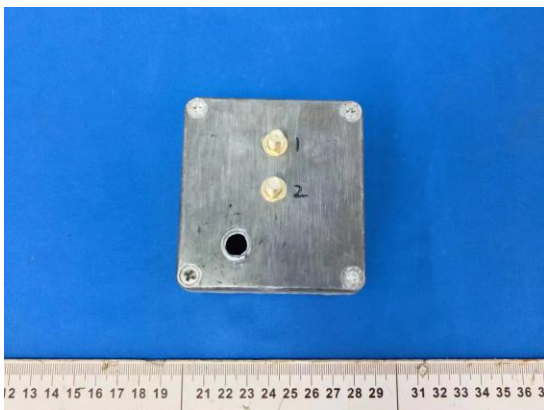
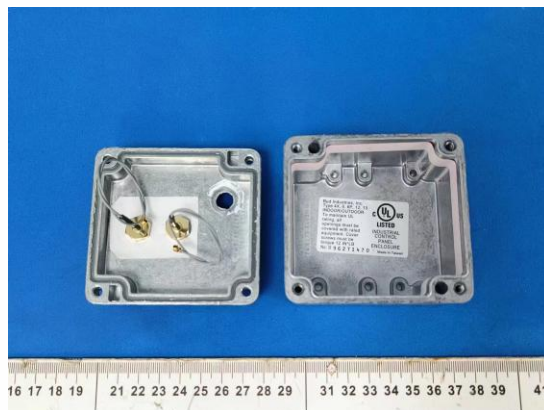
A2230547404101001

Sample Photo(s) after the test
