Test Report

Report No. A221002539210100202R1

Sample Name Isolated RP SMA Straight Bulkhead Jack with O-ring Rated to IP67/68
Lot No. RFCT-SMA086-F78
Sample Receiving State Normal
Sample Received Date Jan. 20, 2021
Testing Period Jan. 20, 2021-Jan. 29, 2021

Test Item: IP6X

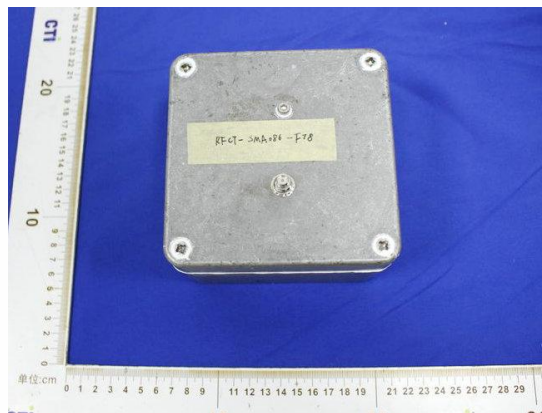
| Sample No. | Sample Name | Quantity |
|---|--|---|
| A2210025392101002 | Isolated RP SMA Straight Bulkhead Jack with O-ring Rated to IP67/68 | 1pc |

Sample Photo(s)

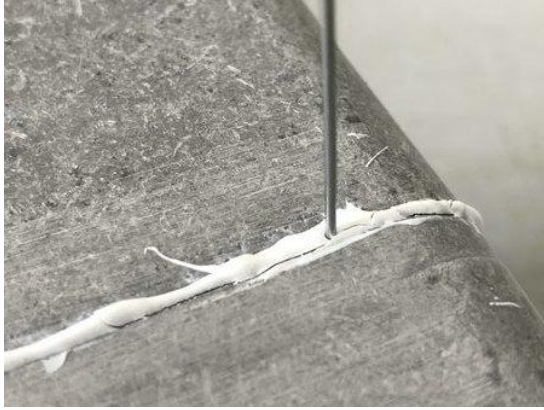
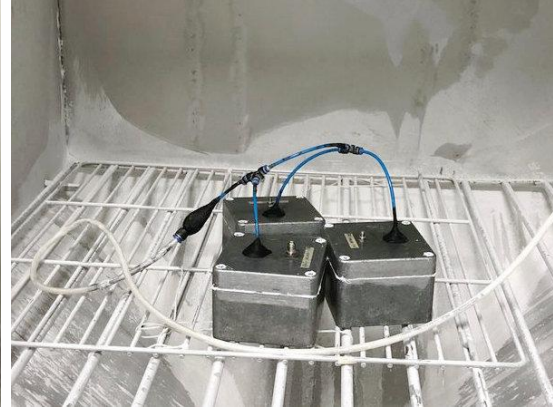
Use a test probe with a diameter of 1mm to probe the gap part of the sample with a force of 1N.

Put the sample in a negative pressure state, the pumping speed is 40-60 times the volume of the shell per hour, and the pressure difference between the pressure in the shell and the atmospheric pressure is less than 2kPa, and continue the test. Place it in a dust-proof test box for 2h.

Test Photo(s)

| Sample No. | Criterion | Test result(Visual inspection) | Conclusion |
|--|---|---|---|
| A2210025392101002 | The probe cannot enter, and there is no dust inside the sample. | The probe cannot enter, and there is no dust inside the sample. | Pass |

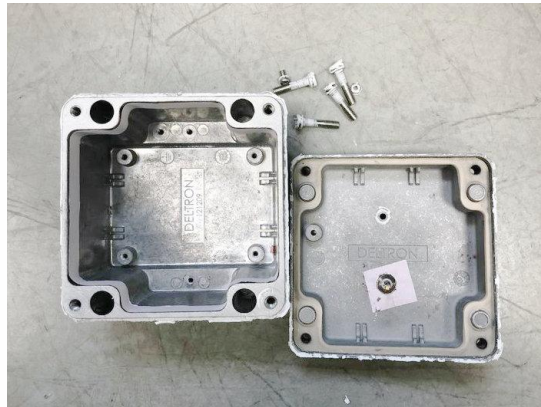
A2210025392101002

Sample Photo(s) after the test
