# Test Report

Report No. A2200397792101002c

Sample Name SMA Jack Nautilus SS with Silicone O-Ring to I-Pex MHF

No.	Test Item
1	IP6X

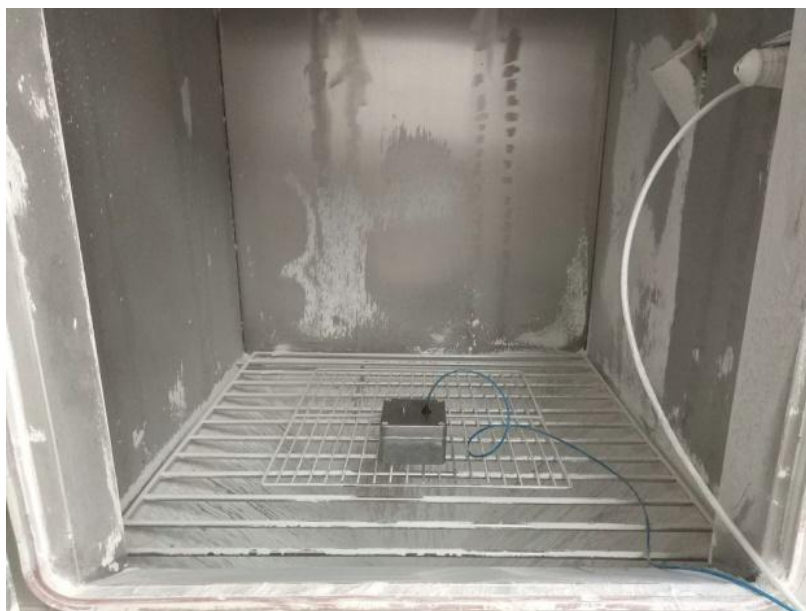
-a) The test prober of 1mm diameter is pushed against any opening of the sample with force of 1 N;

-b) Set the sample in the dust chamber, the pressure inside the enclosure is maintained below the surrounding atmospheric pressure by a vacuum pump (Less than 40 times of the shell volume per hour; the differential pressure between the containment and the atmosphere:  $\leq 2\text{kPa}$  );

-c) The talcum powder to be used is  $2\text{kg/m}^3$  of the test chamber volume;

-d) Test duration: 8 hours.

Test Set-up Photo

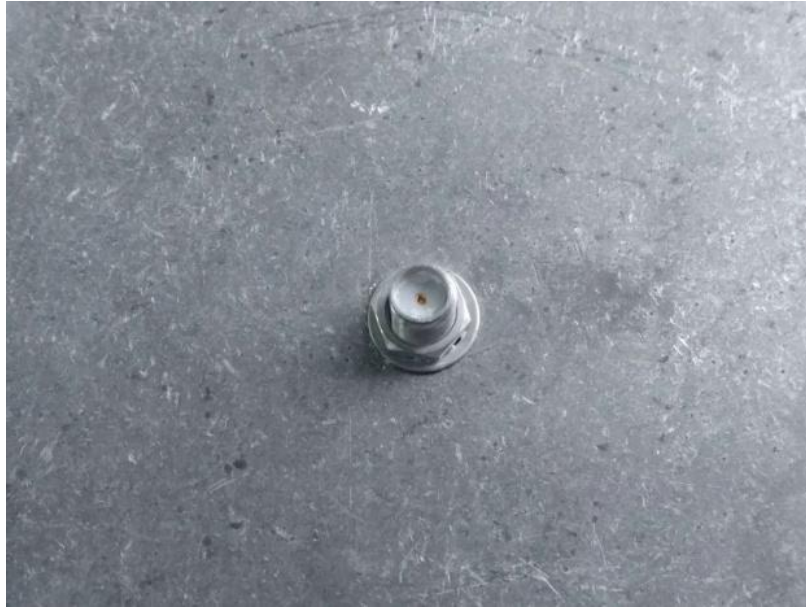
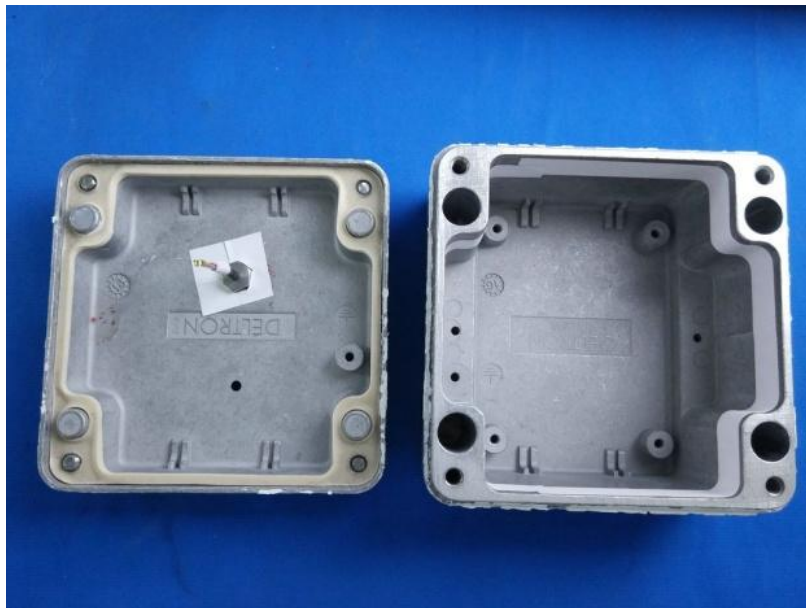
Sample No.	Result	Conclusion
A2200397792101002	Visual inspection, test probe cannot into the sample. No obvious dust was observed in the sample after test.	PASS

## Sample Photo(s) after the test
