Test Report

Report No. A220015853910101

No.	Test Item
1	IPX7

Centre Testing International Group Co., Ltd.

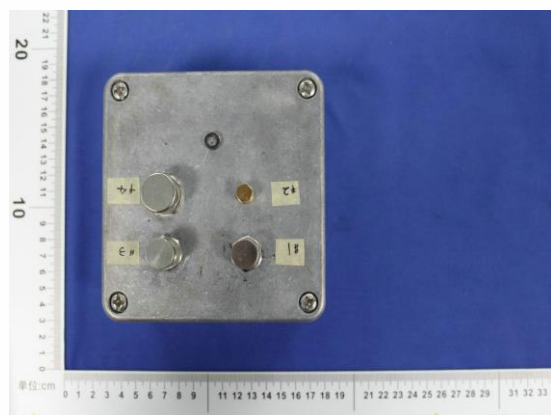
Sample No.	Sample Name	Type	Quantity
A2200158539101001	Metal protective cap with gasket for TNC Jack	RFCT-TNC-CAP-GS-3	1pc
A2200158539101002	Metal protective cap with gasket for SMA Jack	RFCT-SMA-CAP-GS-1	1pc
A2200158539101003	Metal protective cap with gasket for BNC Jack	RFCT-BNC-CAP-GS-3	1pc
A2200158539101004	Metal protective cap with gasket for N Jack	RFCT-N-CAP-GS-2	1pc

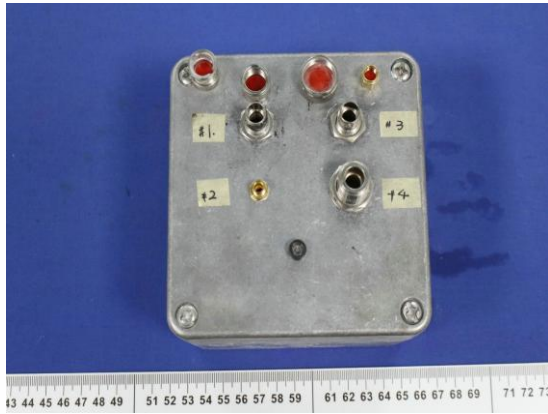
Sample No.	Criterion	Test result(Visual inspection)	Conclusion
A2200158539101001	No water entered into the sample.	No water entered into the sample.	Pass
A2200158539101002	No water entered into the sample	No water entered into the sample	Pass
A2200158539101003	No water entered into the sample	No water entered into the sample	Pass
A2200158539101004	No water entered into the sample	No water entered into the sample	Pass

Sample Photo(s) after the test
