Test Report

Report No. A221002539210100302R2

Sample Name Isolated SMA Straight Bulkhead Jack with O-ring Rated to IP67/68
Lot No. RFCT-SMA085-F78
Sample Receiving State Normal
Sample Received Date Jan. 20, 2021
Testing Period Jan. 20, 2021-Jan. 29, 2021

Test Item: IP6X

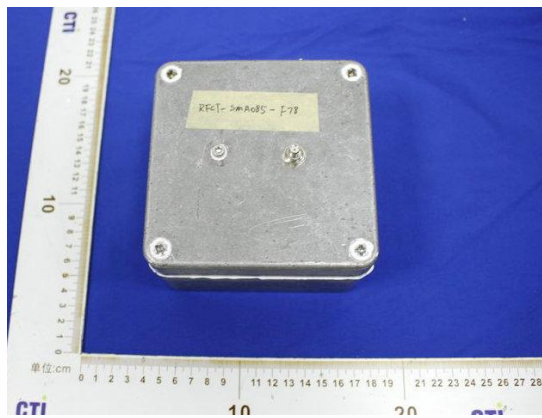
Sample No.	Sample Name	Quantity
A2210025392101003	Isolated SMA Straight Bulkhead Jack with O-ring Rated to IP67/68	1pc

Sample Photo(s)

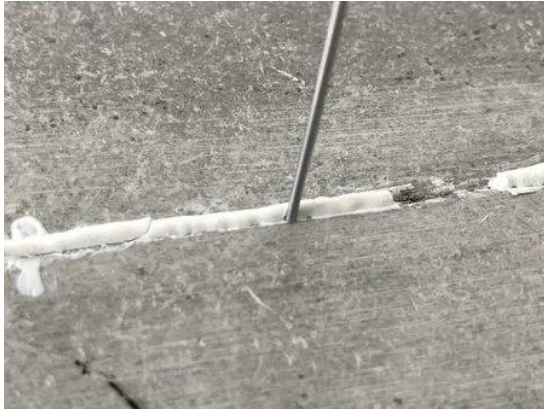
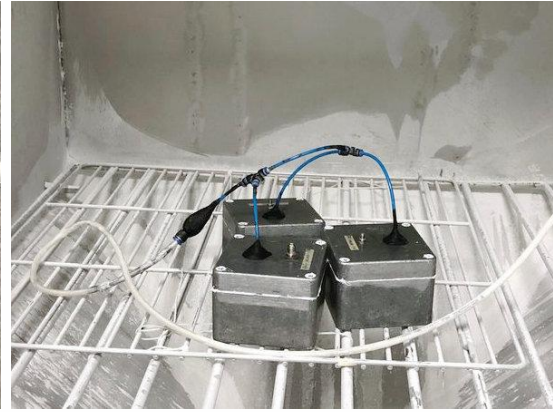
A2210025392101003

Use a test probe with a diameter of 1mm to probe the gap part of the sample with a force of 1N.

Put the sample in a negative pressure state, the pumping speed is 40-60 times the volume of the shell per hour, and the pressure difference between the pressure in the shell and the atmospheric pressure is less than 2kPa, and continue the test. Place it in a dust-proof test box for 2h.

Test Photo(s)

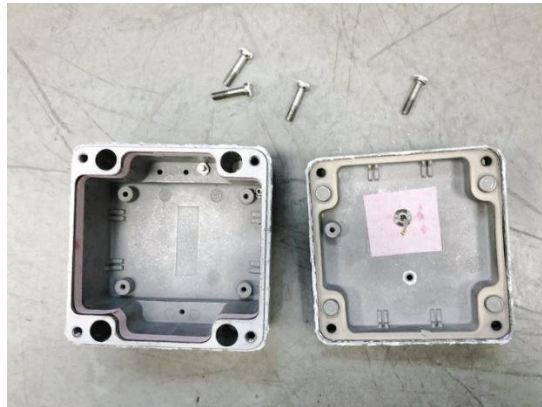
Sample No.	Criterion	Test result(Visual inspection)	Conclusion
A2210025392101003	The probe cannot enter, and there is no dust inside the sample.	The probe cannot enter, and there is no dust inside the sample.	Pass
Note: The judgment basis is provided by the customer

Sample Photo(s) after the test
