Report No. A223036066110103

Sample Name SMA Bulkhead Jack with O-ring
Type RFCT-SMA122-F13
Sample Receiving State Normal
Sample Received Date Jul. 20, 2023
Testing Period Jul. 20, 2023-Jul. 31, 2023

No.	Test Item
1	IP6X

Test Report

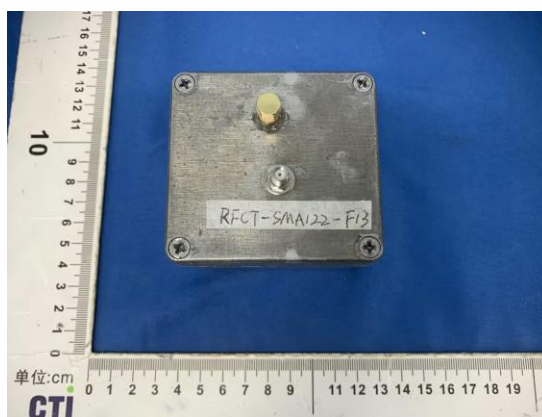
Sample No.	Sample Name	Type	Quantity
A2230360661101001	SMA Bulkhead Jack with O-ring	RFCT-SMA122-F13	1pc

Sample Photo(s)

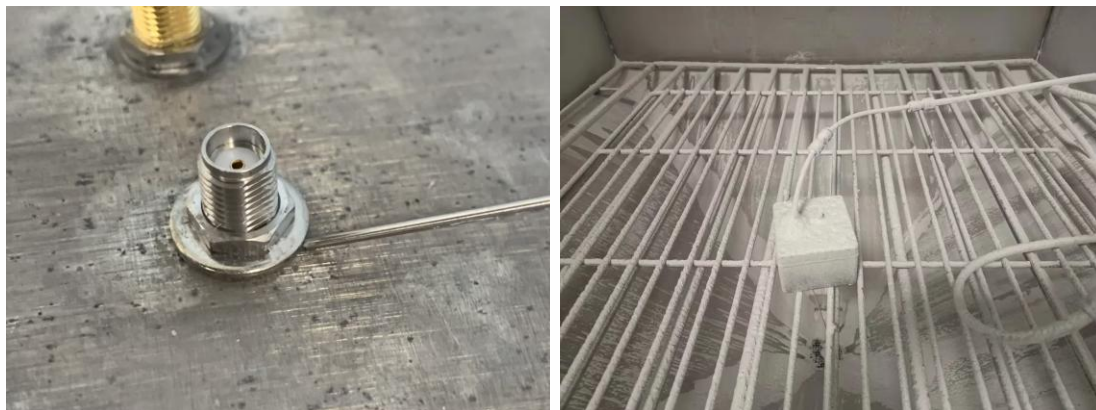
A2230360661101001

Use a test probe with a diameter of 1mm to probe the gap part of the sample with a force of 1N
Put the sample in a negative pressure state, the pumping rate is 40-60 times the volume of the shell per hour, and the pressure difference between the pressure in the shell and the atmospheric pressure is less than 2kPa, and the test is continuously performed for 2h in the dust-proof test box.

Test Photo(s)

Sample No.	Criterion	Test result (Visual inspection)	Conclusion
A223036066 1101001	The test probe cannot enter the interior of the sample, and there is no dust entering the interior of the sample.	The test probe did not enter the interior of the sample, and there was no dust entering the interior of the sample.	Pass

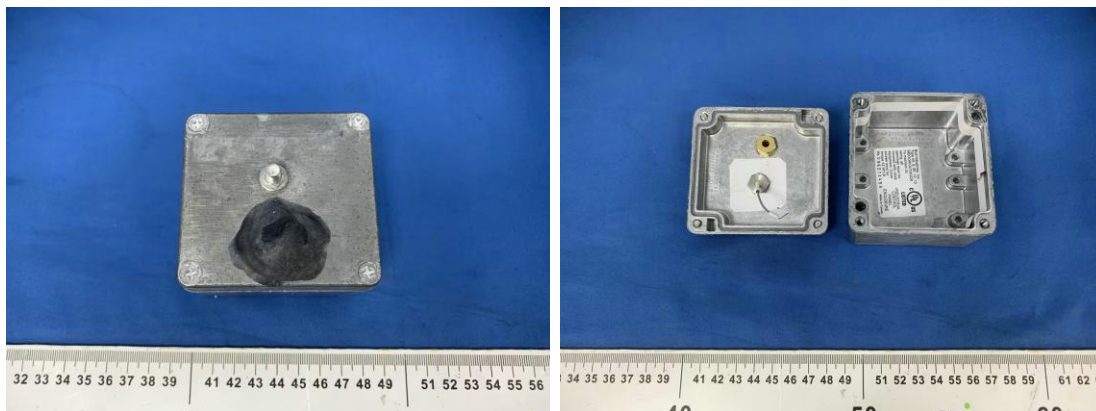
A2230360661101001

Sample Photo(s) after the test
