Report No. A223050212310102 Page 1 of 5

Sample Name Stainless Steel RP SMA Right Angle Bulkhead Jack with O-ring

Type RFPC-SMA24-FN

Test Item: IPX9K

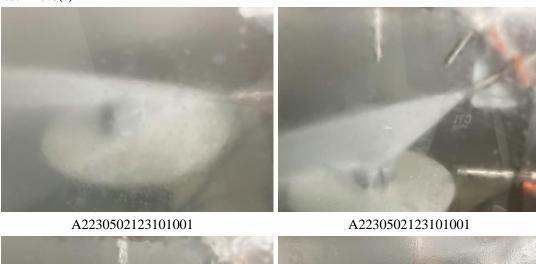
Test Photo(s)

Test Angle:0 °,30 °,60 °,90 ° respectively

Water spraying distance:100mm~150mm

Rotary speed:5r/min

The water temperature:80 $^{\circ}$ C

Water flow:15L/min

Test time: Test each Angle for 30s

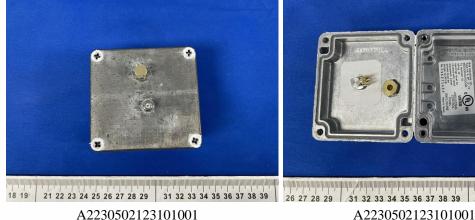
Sample Photo(s) after the test

Sample No.	Criterion	Test result (Visual inspection)	Conclusion
A2230502123101001	No water enters the sample	No water enters the sample	Pass
